How i repaired my 33%Krill fuselage, landinggear area.

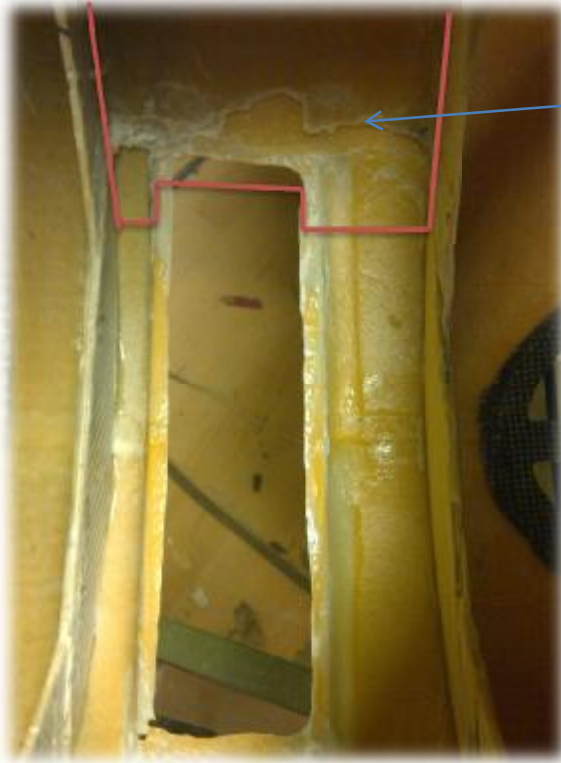
Old Plywood removed and some of delaminated inner laminate.

Two layers of 165g/m² glasfibre added up to fuselage plywood longeron. (Red lines..)

Rectangular hole milled from outside to make removal easier.

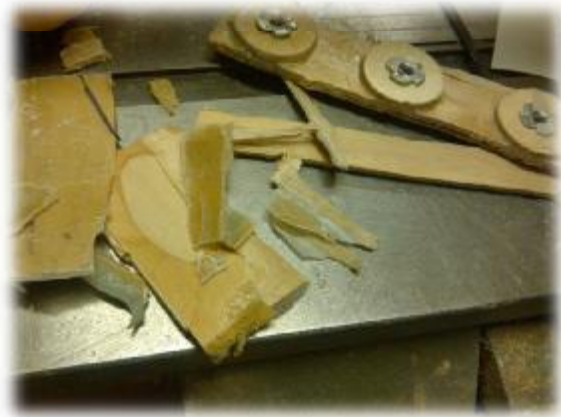
Removed plywood and laminates from the Fuselage.

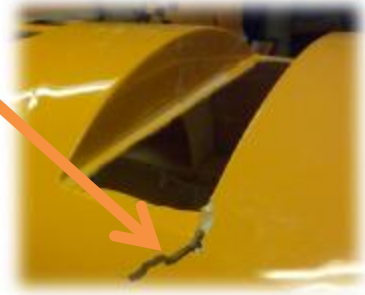
Broken Sandwich is repaired by remove inner laminate and also the sandwich material carefully. If outerskin is broken I also remove this with a thin endmill.

In this case a thin tape could be placed on outer skin..

I fill the missing sandwich panel with epoxy and microfiber, make

Sure fill well to remaining sandwich panel. I put a layer och 163g/m²

Glasfibre in insidelaminate.
